Functional Assessment of a Square: Case of Düzce Anıtpark

Özgür Yerli

Düzce University Faculty of Forestry, Department of Landscape Architecture, Düzce-Turkey, 81620

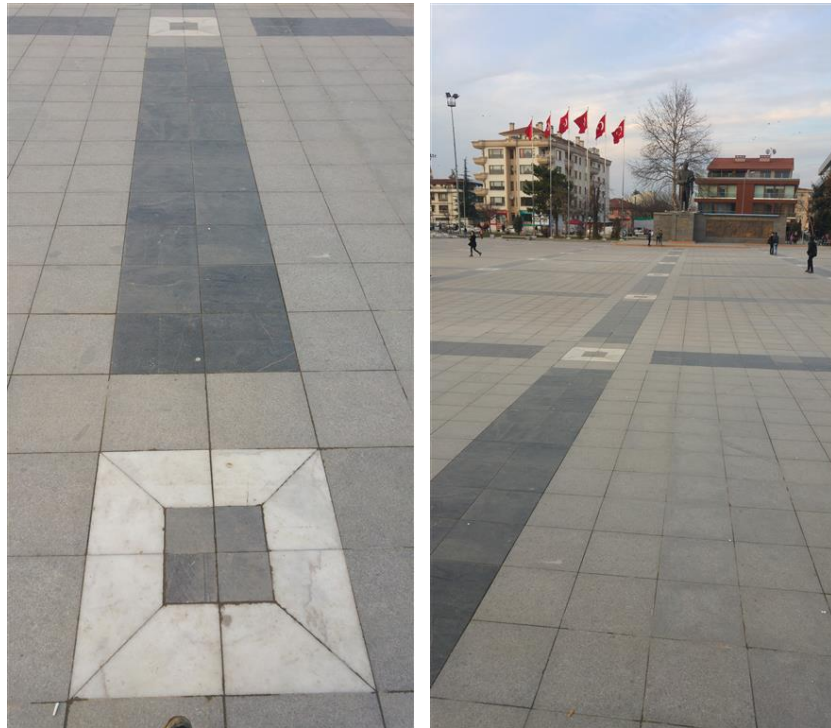
Figure 4. The pavement materials of Anıtpark.

Two types of stones were used including grey granite and black basalt stone as pavement materials as in general in the city center of Düzce. Also white marble was added in order to create patterns on the floor, to strengthen the effects of the lines and to add colour. It is notable that all the used materials are smooth and fine. Images regarding the used flooring were given in Figure 4.

According to the survey result, flooring function is absolutely needed in a square and the flooring quality of the Anitpark was found to be sufficient. As a result of the observation made in the field except of some moving stones, broken or poor quality pavement was not observed and also unpaved areas were not seen. The difference which was almost 1 point emerged due to use of the black coloured basalt stones.

Because particularly in winter this stone prone to icing while in the summer it absorbs the heat due to its dark colour. So the pedestrians may experience problems in both seasons.

The broken pavement stones should be renewed while the black basalt stones should be replaced with another material that does not absorbs the sun in the summer and does not keep ice easily in the winter. In certain times of the year heavy machinery is needed for the preparation of the events to be held. These machineries damage the flooring elements of the square. It should not be allowed or the infrastructure of the pavement should be rearranged in a way that allows the machineries to work there. Within the square, low and medium high lightening elements should be placed and the function of these elements should be increased by strengthening the sitting, resting and shadow elements within its near environment. In this way, the quantity of the shadow elements whose lack was perceived can be increased. All of the garbage collecting functions should be changed with leak-proof easily accessible garbage collecting elements produced from materials which could not be easily damaged. If it is possible this problem should be solved

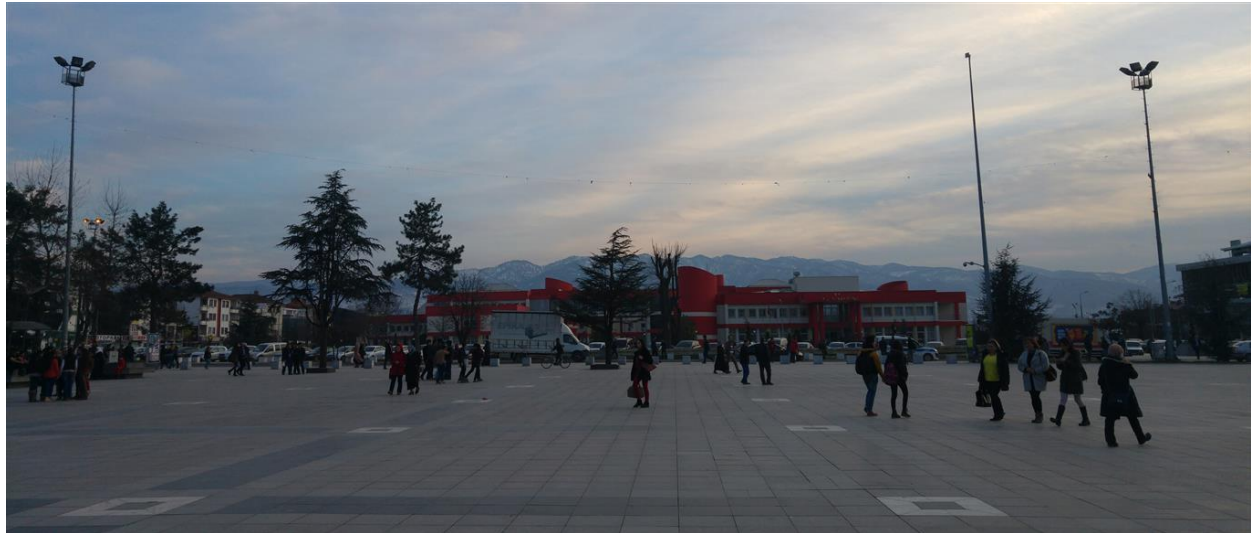
Figure 5. High lightening in Anıtpark and the Governor's Builgind in the background.

The rarity of the lightening elements within the border of the Anıtpark area was observed during the inspection work. Road and junction lightening were used at the four corners of the Anıtpark and on the roads forming the border. Additionally, to the east at the area of the sitting and recreation function lightening elements were located in human scale. In Figure 5 images were given in relation with the high lightening of the Anıtpark.

According to the survey result although lightening function is a condition which is expected to be in a general square, the lightening quality of the Anıtpark was sufficient. As the result of the observations, the lightening elements were found to be too rare in human scale. Despite this, the fact that the difference was very little showed that the demand for the lightening function was also not too high in general. According to the field observations of the previous years, ground lightning elements were place in Anıtpark but in a very short time they became unusable because of vandalism and with the new arrangements they were completely removed.

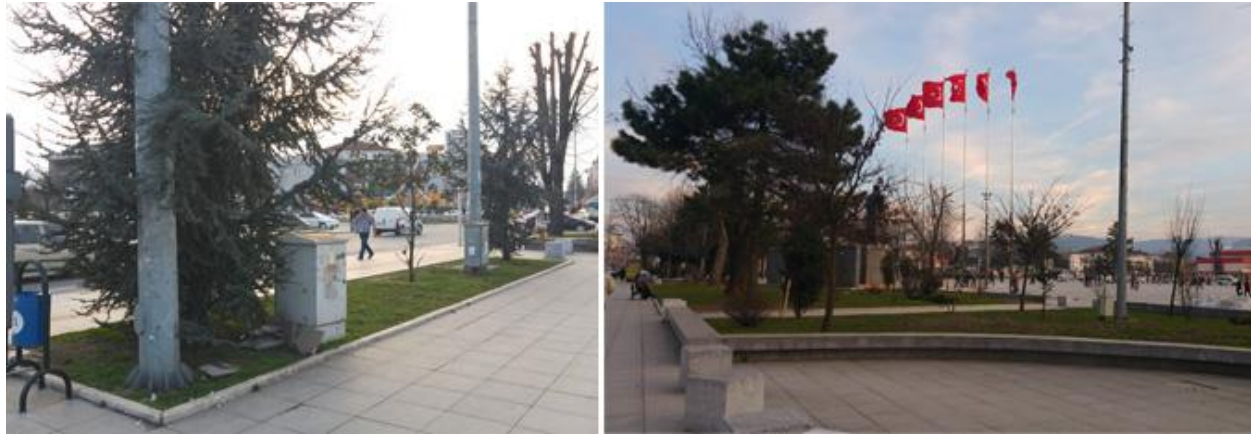
Figure 6. Usage of the plant material in Anıtpark.

In Anıtpark the plants are located almost like a siege around the square. The green areas constitute approximately 15 % of the total area. When examining the green areas which include the herbal materials it is worth noting that the green areas were used as surrounding elements in the east, west and north side of Anıtpark. Especially behind the Atatürk monument located in the north the high trees created a background. It was seen that the plants consisted of green and needled trees, bushes and grass. Images related to the plant materials were given in Figure 6.

According to the survey result, the presence of the plant function was stated to be good in a square, the presence of plants in Anıtpark was neither good nor bad. In other words the presence of plants in Anıtpark was less appreciated. As a result of the conducted field observations, it was seen that the herbal ingredients used within the Anıtpark were worn by the urban uses, the form of the plants was deteriorated and the grass was neglected. The 1 point difference between was thought to arise from this cause.

with underground garbage collection areas which have been used frequently. The green fields should be strengthened by including species from the following groups grass and other groundcovers, seasonal plants evergreens and deciduous shrubs and trees. The maintenance of these green fields should be done regularly. The green spaces which have been created in this way will not be used only as a green area but will bring along the use of the functions such as sitting, resting shadow and siege at the same time.

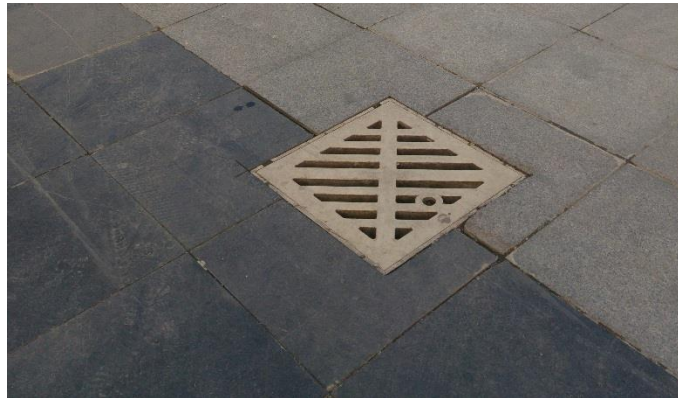
Figure 7. Part of the drainage system in Anıtpark.

The drainage in Anıtpark is provided by surface and underground removal system. According to the observation made on rainy days there were areas where the rain water was not drained. Figure 7 showed the rack which was a part of the drainage system in Anıtpark.

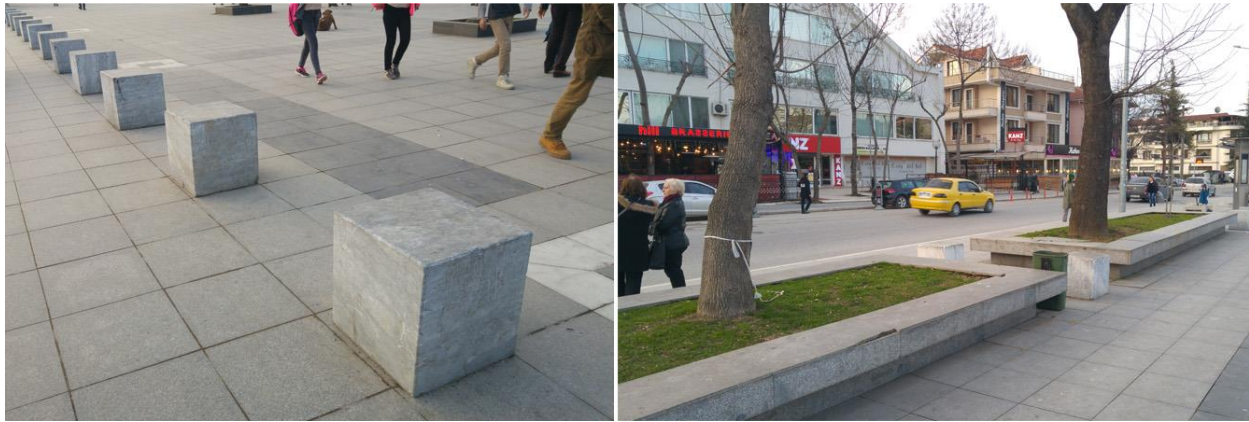
Figure 8. The examples of siege elements in Anıtpark.

In Anıtpark, concrete blocks in cube form placed next to the plant materials in the east, west and north and in the south sitting units placed next to each other are used. . The cubes of concrete blocks in the south of the area prevent both the entry of the vehicles to Anıtpark as well as it separates the sidewalk areas from the work area. Also in the west of the area the place surrounded by herbal materials was converted into a seating wall by increasing it with about 50 cm and covering it. Thus one use had multiple functions. Images in relation the siege elements were given in Figure8.

According to the survey results, the availability of the siege function in a square did not really matter, so the siege function of the Anıtpark was beyond the expectation and was considered sufficient. As a result of the field observations, the cubic stone blocks in the south were used not only for separating the boundaries but also as a playing tool by the children. The kids were climbing on them and jump down and were running in zigzag between them. The cubic blocks were moved to different points for different activities from time to time. But due to their heavy weights, their transport is carried out by caterpillars and this situation gave physical damage both to the floors and to the cube blocks as well.

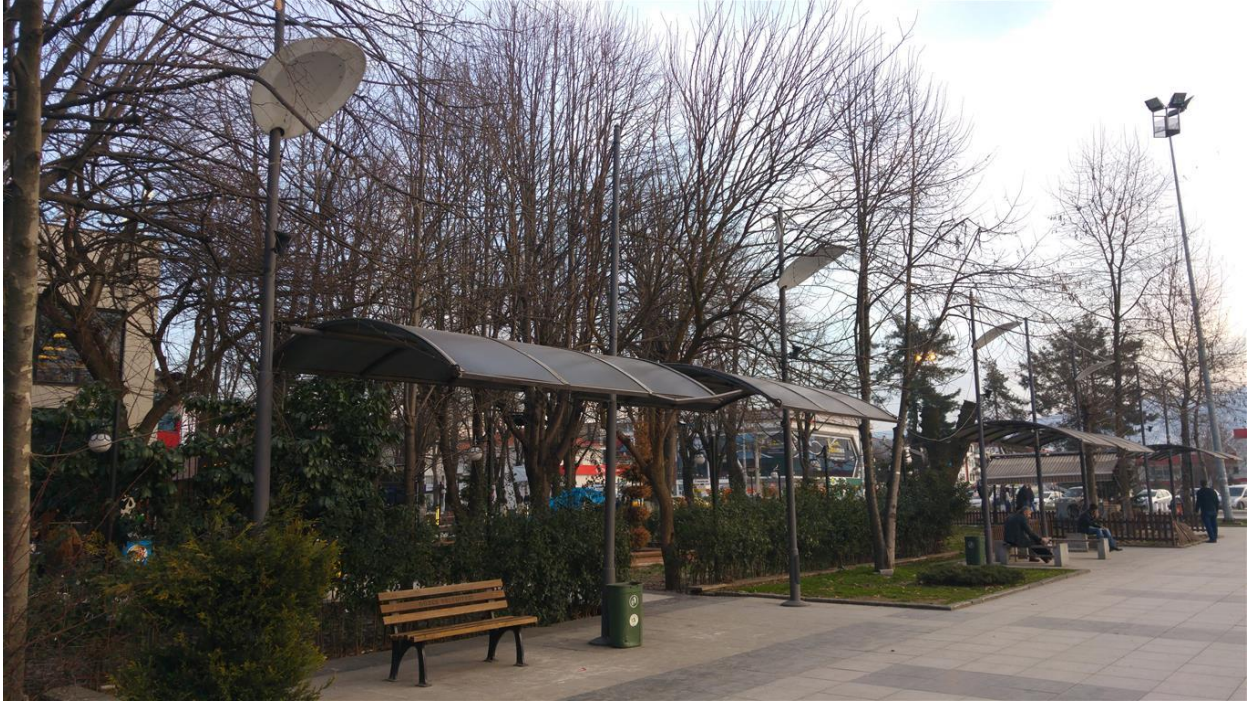
Figure 9. The examples of shadow elements in Anıtpark.

In the Anıtpark artificial canopy is used as shadow material in the western boundary of the area. The trees within the green area in the western border also serve as shadow elements. The shadow elements are used side by side with the lightening, waste and recreation functions on a linear line. This can be considered as an example for using more functions together at the same venue. The shade elements used in Anıtpark were given in Figure 9.

According to the survey result the availability of the shadow function in a square was considered to be good in general. The shadow function of the Anıtpark was neither sufficient nor insufficient. As a result of the observations the number of the shadow elements used in Anıtpark was less (only 8 pieces) they were placed on a single straight line. It is suggested that difference which was almost 1 point was caused by this.

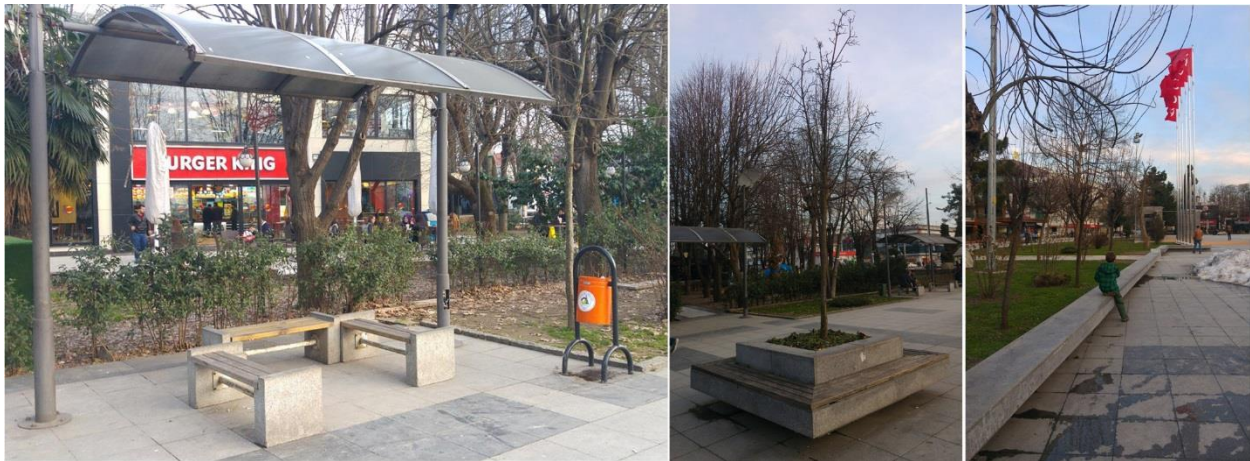
Figure 10. The examples of resting elements in Anıtpark.

The applications which are located in Anıtpark for resting consists of backrest and backless seat units and sitting elements around the trees together with the shadow function in the eastern boundary of the area. Besides, the sitting wall surrounding the green area in the western and northern border and the cubic stone blocks overtake the sitting function. The stepped structure around the Atatürk statue placed in the northern central part of the area is mostly used by the people for sitting and resting. The resting elements in the Anıtpark are given in Figure 10.

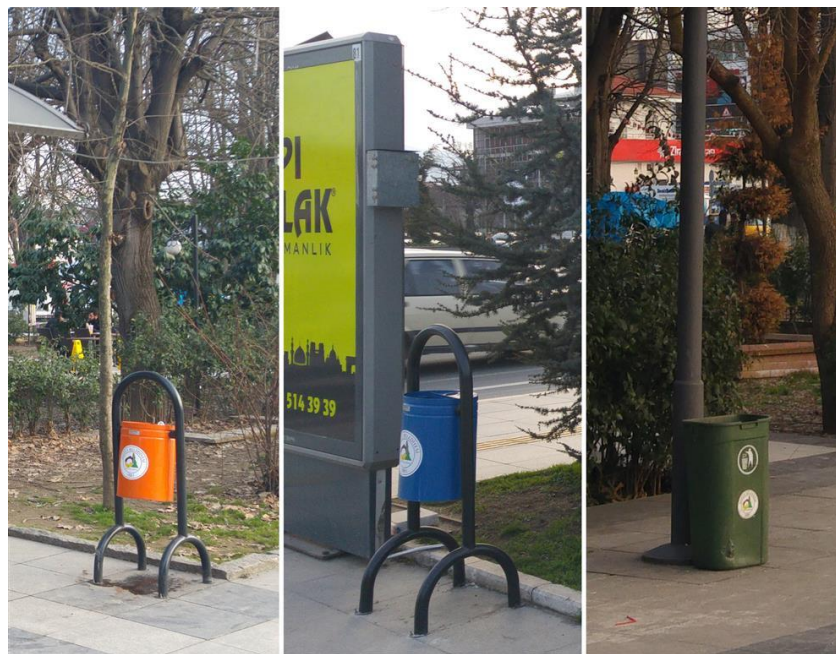
Figure 11. The examples of garbage collection elements in Anıtpark.

Mobil and fixed dustbins were placed at various points of the Anıtpark in order to fulfil the garbage collecting function. The dustbins which made of plastic and iron were used most intensively on the eastern border where the resting elements were placed. The garbage collecting elements were given in Figure11.

According to the survey results while in general the garbage collecting function is certainly needed in a square, the garbage collecting function was observed as neither sufficient nor insufficient in Anıtpark. As a result of the field observations the number of the dust collecting elements was few while the existing dust collecting elements leaked especially the liquid waste and caused bad and nasty view. It is suggested that the difference which was 1,5 point occurred due to this reason.

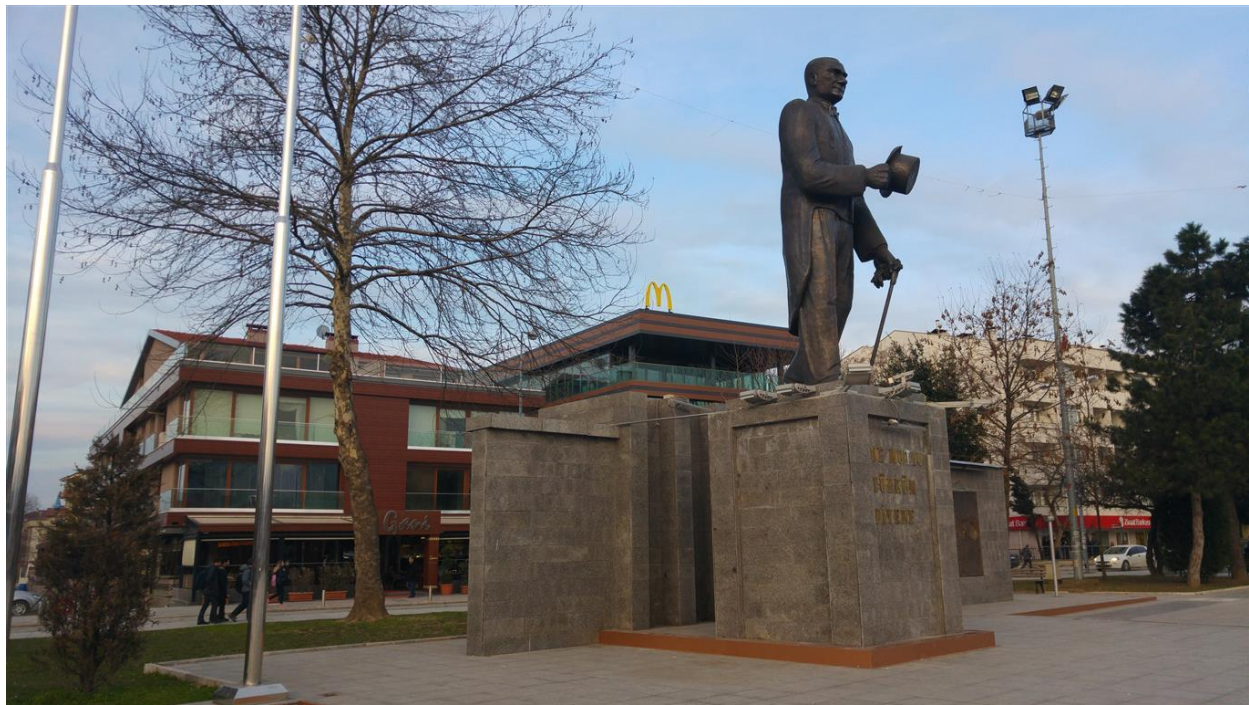
Figure 12. The plastic element in Anıtpark.

There is only an Atatürk Statue as plastic element in Anıtpark. All the official ceremonies held in Düzcce are performed in front of this statue. The statue is situated in the north of the area and looks towards south. The statue which is rather large can be seen easily from any points. The base of the statue is one step higher than the floor and it is used by the people for sitting or resting. An image was given in relation with the plastic element in Figure 12.

According to the survey results the availability of the plastic element faction did not matter in a square in general but the plastic element function in Anıtpark was observed to be definitely sufficient. It is suggested that the difference which was almost 1 point was caused by the considerable size of the statute by the fact that in Düzcce it is the only place with such a monument and a place and by the fact that the name of the area come from the word monument.
